Sacred Heart Sisters

Kalungu Girls Secondary School

Improvement of Water & Sanitation Infrastructure

February 2003 – December 2003

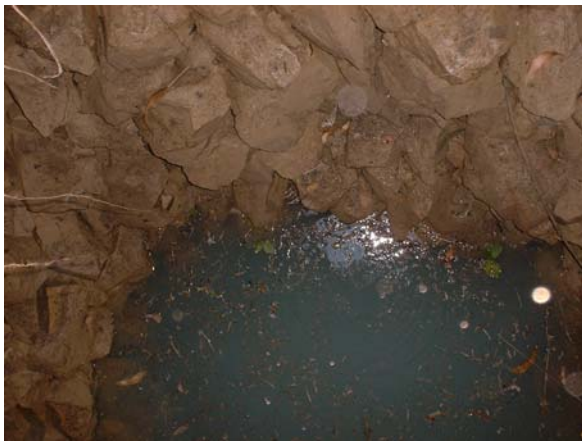
Picture 1: old water source of the school

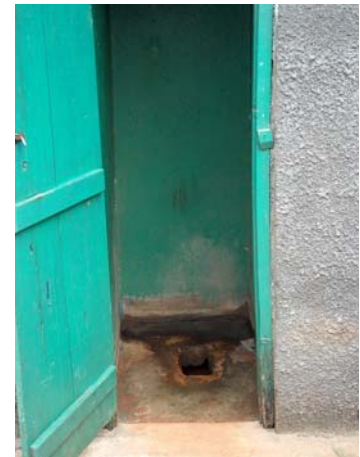
(flush toilets and grey water from kitchen and showers) was drained away in soak pits. Human waste from the pupils was disposed of via app. 35 pit latrines. Grey water from showers and kitchen was discharged into a ditch outside the school's compound and drained.

Picture 2: old pit latrines

In addition also the water sources were not constructed properly, minimizing the risk of secondary pollution. Therefore, to reduce the groundwater (drinking water) pollution, it was planned to replace the pit latrines by dry toilets and treat the remaining

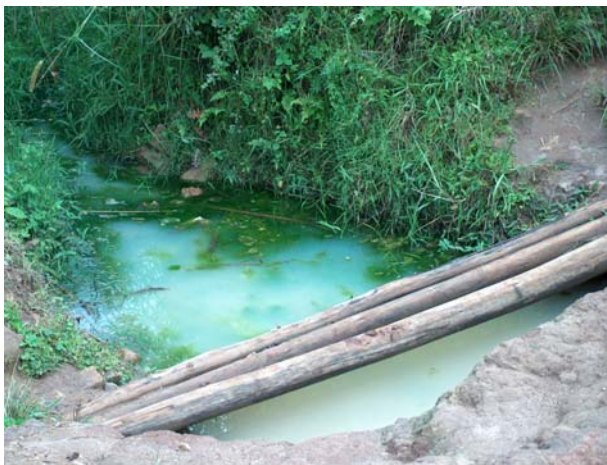
Picture 3: water source for the village

In addition it was foreseen to renew the spring catchment to reduce the risk of water pollution due to entry of surface water. A borehole on the schools compound, which was equipped with a hand pump, was planned to be used for supplying drinking water to the sisters house and the schools kitchen by installing a submersible solar pump and a drinking water tank.

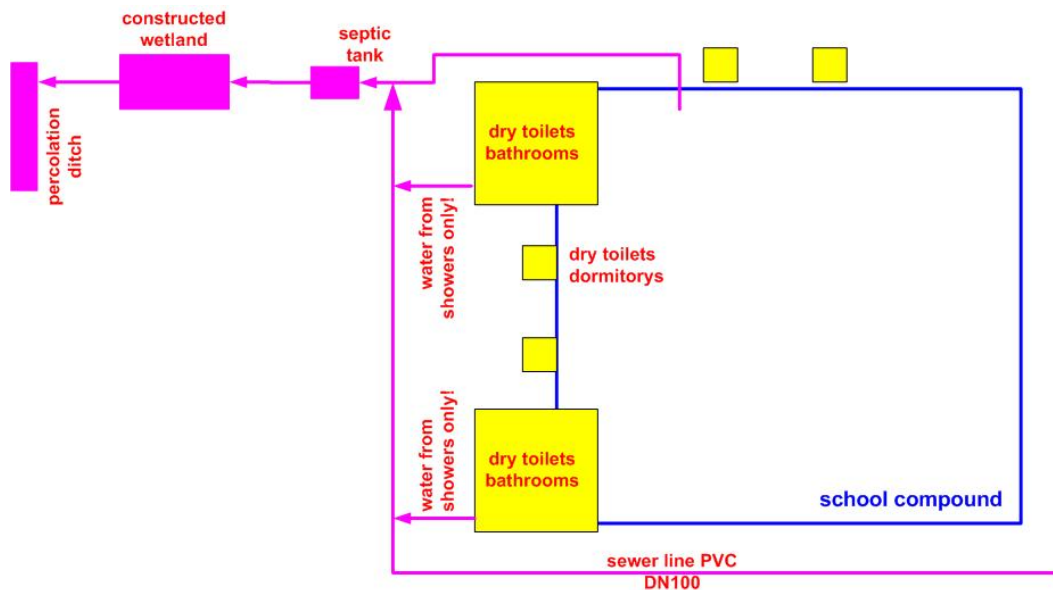
wastewater – grey water with a small share of black water – in a horizontal subsurface flow constructed wetland. The basic scheme is shown in Figure 1 below.

Figure 1: sanitation system KGTC

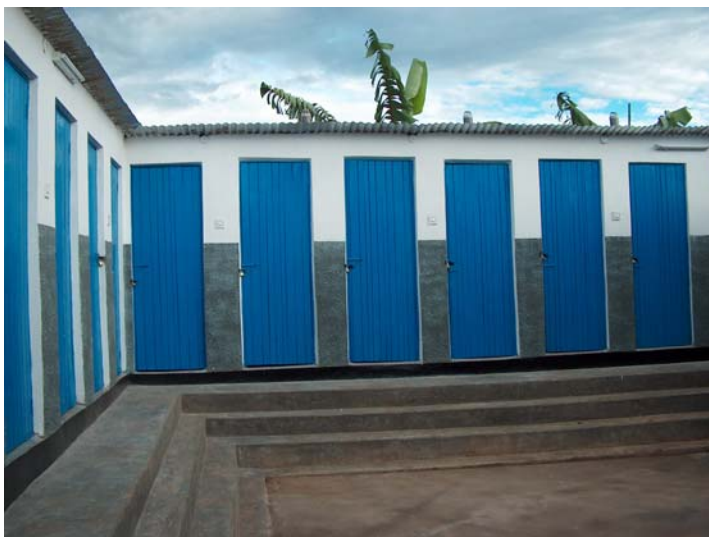
children were constructed. Since only insufficient experience for composting toilets in Uganda was available diversion toilets were selected. In addition, though secondary treatment of the excreta has to be considered, maintenance is less complicated than for composting toilets.

Picture 4: dry toilets

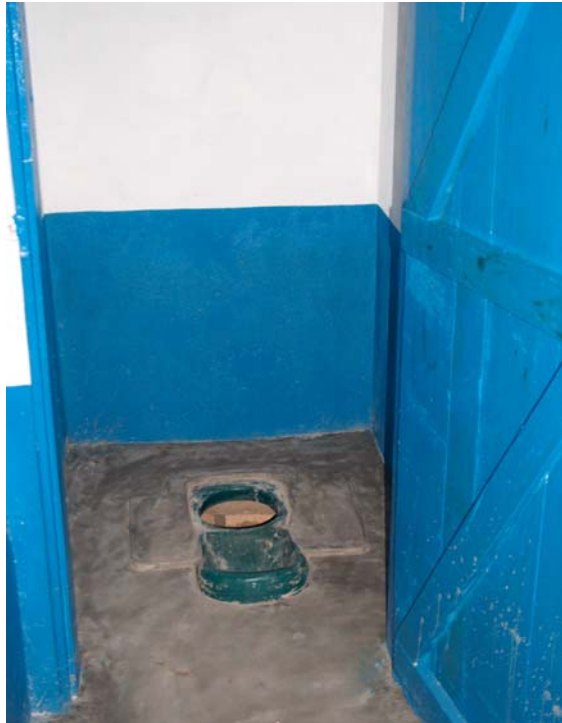
Picture 5: dry toilet, detail

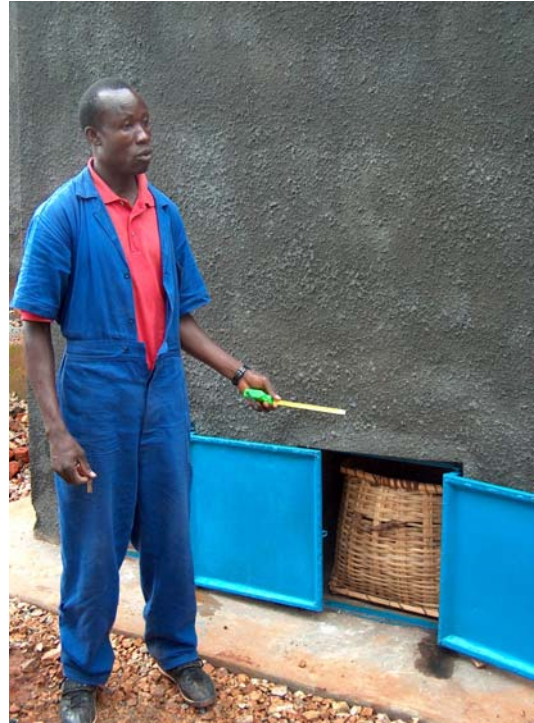
Picture 6: dry toilets; backside with door and basket for faeces

Presently diverted urine is drained in soak pits although reuse as a nitrogen rich fertilizer is optional. Faeces are collected in baskets which are changed regularly. Reuse for agriculture is planned, another project presently in preparation.

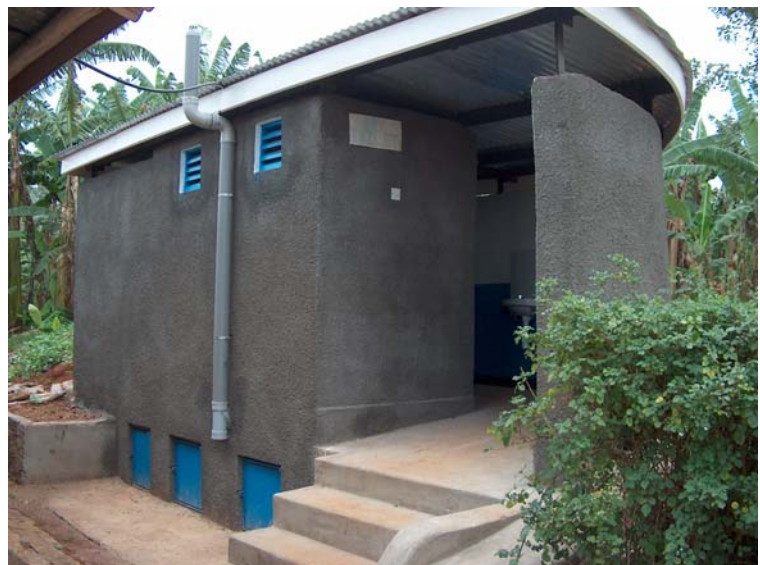
In addition to these dry toilets a dry toilet unit was constructed for the staff and in serving as a demonstration unit for guests. It is located near the main entrance to the school.

Picture 7: Demonstration toilet

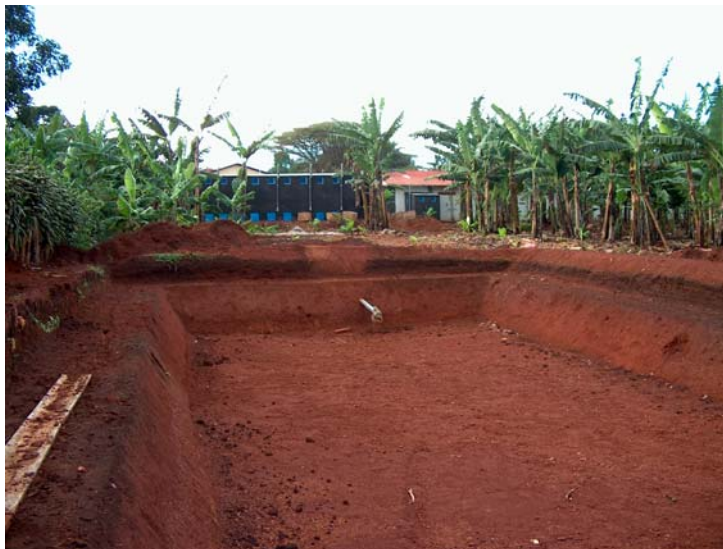
Wastewater is pre-treated in a septic tank to remove solids (by sedimentation and flotation)

Picture 8: Constructed wetland system during construction

before it flows by gravity to the inlet area of the constructed wetland system.

This inlet area comprises coarse aggregate (6-8cm) to distribute the wastewater horizontally before it enters the actual treatment part which consists of sand (4-8mm). At the lower end (bottom slope app. 1%) of the filter bed another area of coarse aggregate, covering a drain pipe (PVC DN100) collects the

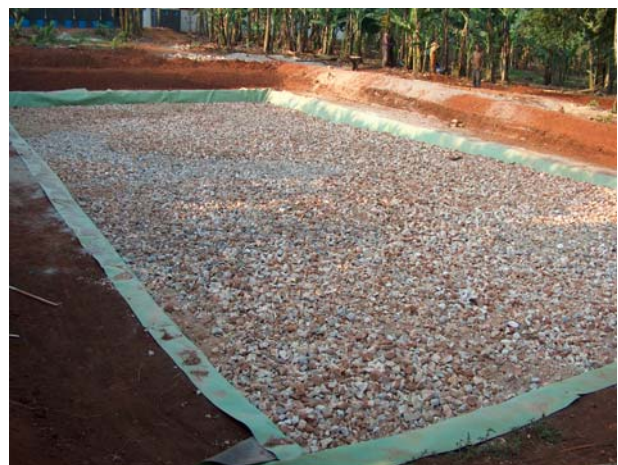
purified wastewater, which is piped via an outlet manhole to an underground percolation ditch (10m of drain pipe DN 100 – parallel to contour lines – in a layer of coarse aggregate and covered with soil/excavated material).

Picture 9: Constructed wetland completed (not yet planted)

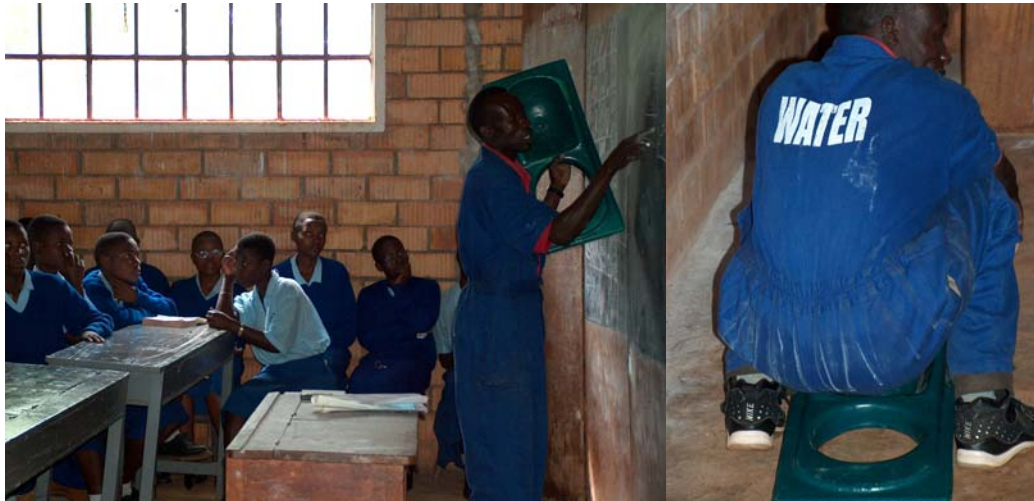
Picture 10: Site engineer explaining & demonstrating the use of dry toilets

Sustainability of infrastructure strongly depends on operation and maintenance from users and o&m staff. For this reason both teachers and students were trained in principles and proper operation of newly constructed units, in particular the dry toilets. For the teachers a brief written summary on the principles of dry toilets, operation and maintenance was prepared.

The responsible personnel for operation and maintenance was trained both on site by the contractor's personnel and in a training course at the Lacor Hospital in Uganda.

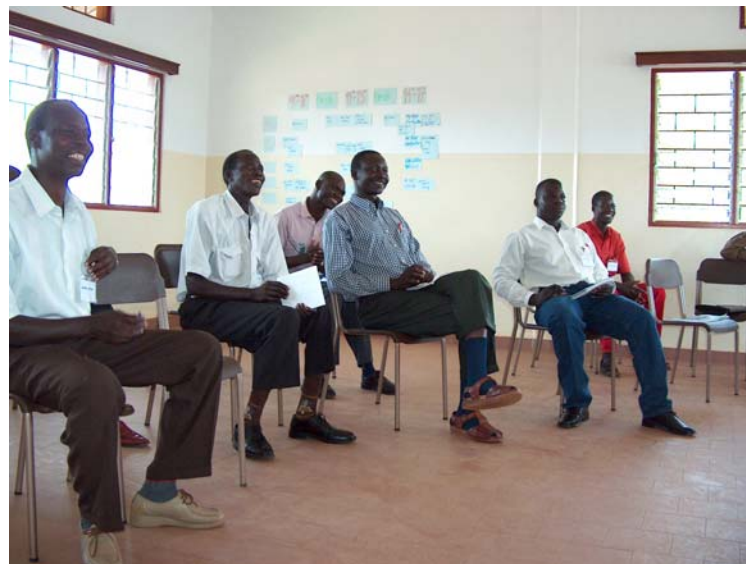
Picture 11: Sanitation training course at Lacor Hospital

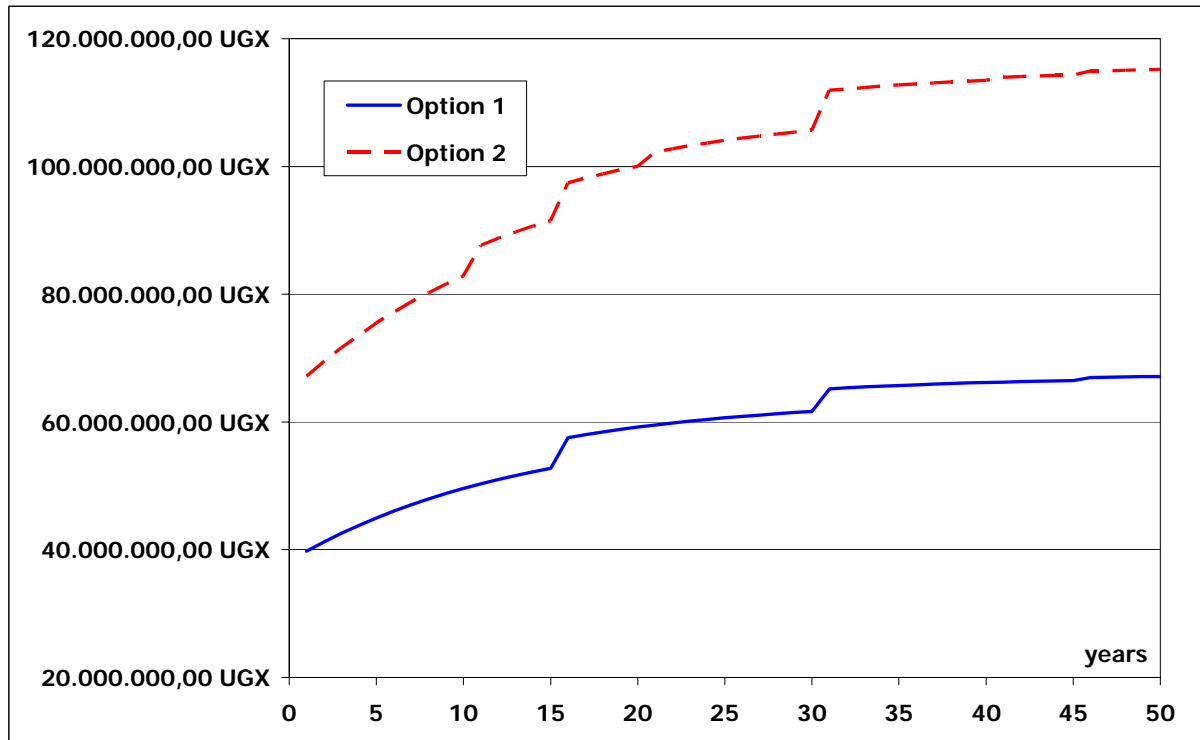
The comparison of costs between a conventional (option 2) and an EcoSan concept (option 1) shows clearly that not only ecological but also economic reasons support the decision to invest in Ecological Sanitation. The main difference is caused by the significantly smaller wastewater treatment system for option 1 and the pumping station additionally required for option 2.

Figure 3: Comparison of costs

for a conventional sanitation concept (option 2) and an EcoSanitation concept (option 1). Figures are in Ugandan Shillings (exchange rate by 22.09.2004: 1€= 2060 UGX).

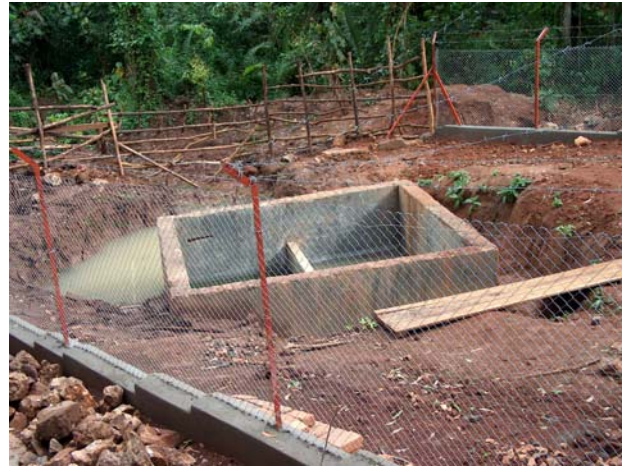
Picture 12: catchment chamber during construction

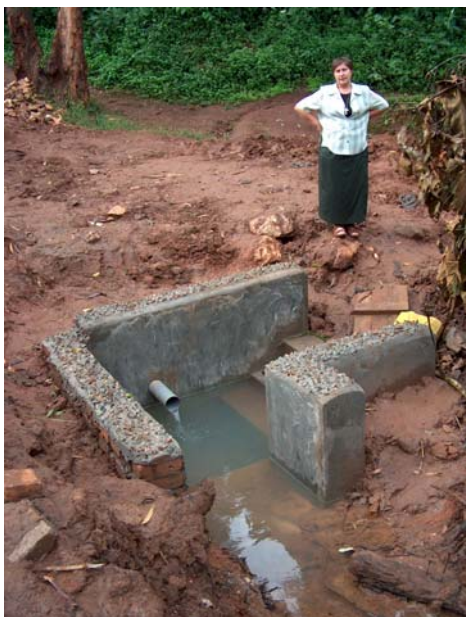
Picture 13: Spring overflow during construction
