Looking back on implementation projects from the last 10 years

This paper revisits implementation projects carried out by EcoSan Club during the last 10 years.

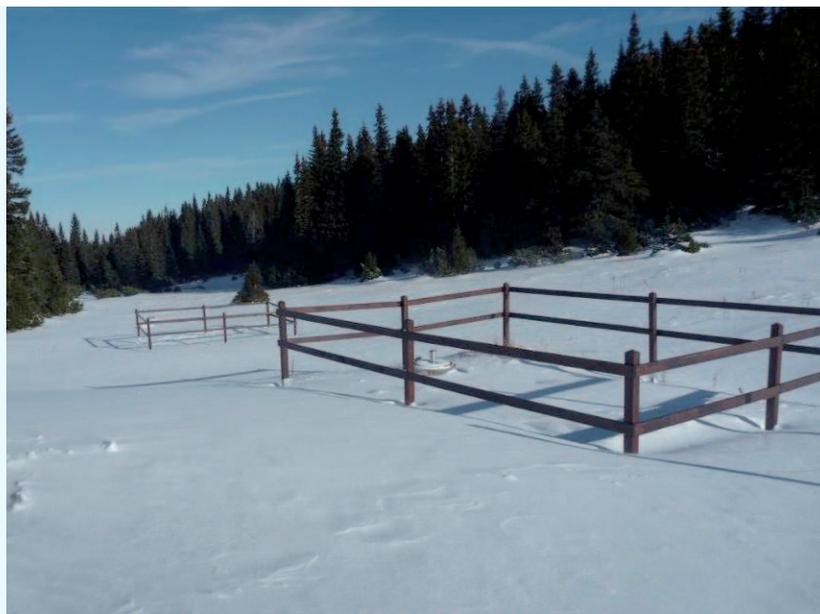
Figure 1. Vertical flow constructed wetland and infiltration system in winter.

for the drinking water supply. The system comprises composting toilets for human excreta management with an additional secondary composting step, a waterless urinal and the treatment of greywater in a vertical subsurface flow constructed wetland system before infiltration. Both in order to equalise the load to the treatment system as well as to enable recirculation of treated wastewater during wintertime (infiltration not possible) a buffer tank was foreseen. For a more detailed description of the system see Freiberger and Weissenbacher (2011).

A: No, there were 2 main problems: 1) the power supply from the photovoltaic system turned out to be too weak for the pumps installed and therefore the process control was not functioning, and 2) the owners did not carry out the few operational measures needed all the time.

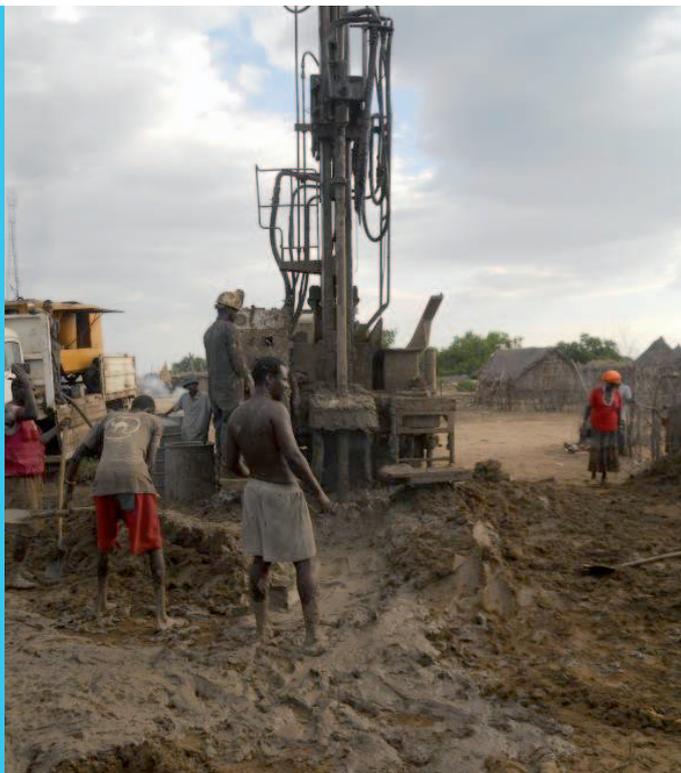
Figure 2. Borehole drilling, Ethiopia.

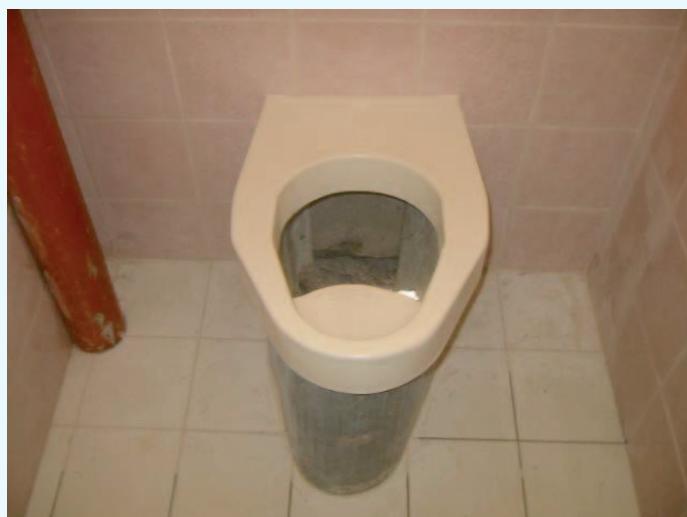
Figure 3. Toilet seat for a Urine-Diversion Dehydration Toilet (UDDT).

The project supported the establishment of a new Health Centre with the design and construction supervision of the water supply and sanitation infrastructure. Drilling of boreholes, catchment of protected springs, rainwater harvesting and the storage and distribution system were included on the water side, while on the sanitation side the entire hospital was equipped with newly design indoor dry toilets and decentralised greywater treatment systems.

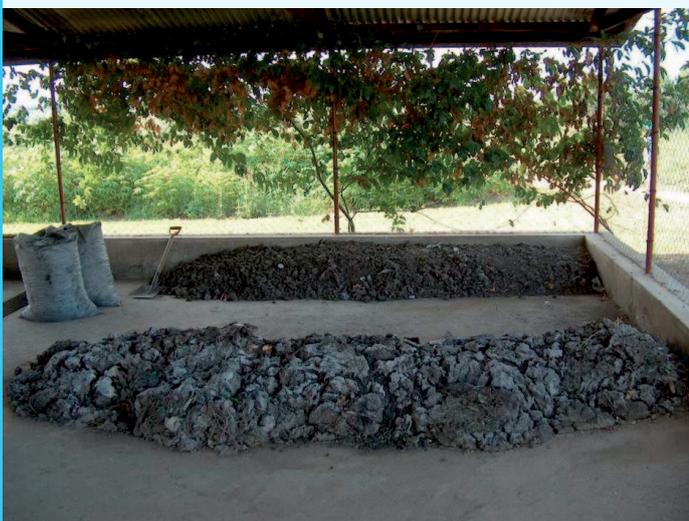
Figure 4. Faecal compost, Maracha hospital.

A: Composting works well as there is a benefit from the faecal compost. The syphon for flushing the vertical flow constructed wetland broke several times. Although it was replaced repeatedly by us (after the project duration) the owners did never replace the spare parts by themselves.

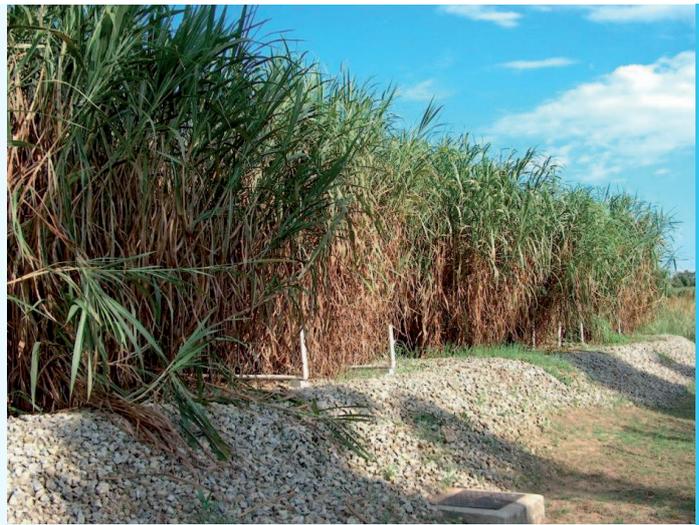
Figure 5. Constructed wetland at Maracha hospital.

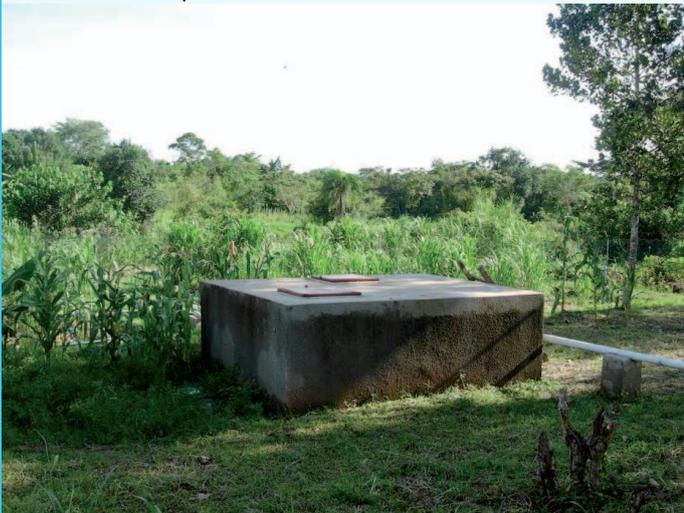
Figure 6. Mechanical pre-treatment of wastewater upstream secondary treatment in a constructed wetland.

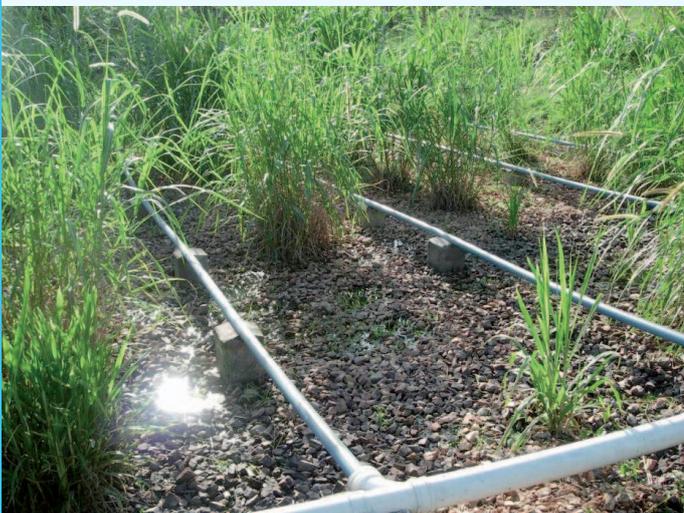
Figure 7. Constructed wetland at St. Franzis Naggalama Hospital.

A: The local implementation partner did not fully understand how the constructed wetland system works. Therefore, sand that is not suitable (not washed and wrong grain size distribution) has been used for filling the beds. Finally the sand had to be removed and washed before the refilling of the bed could be carried out.

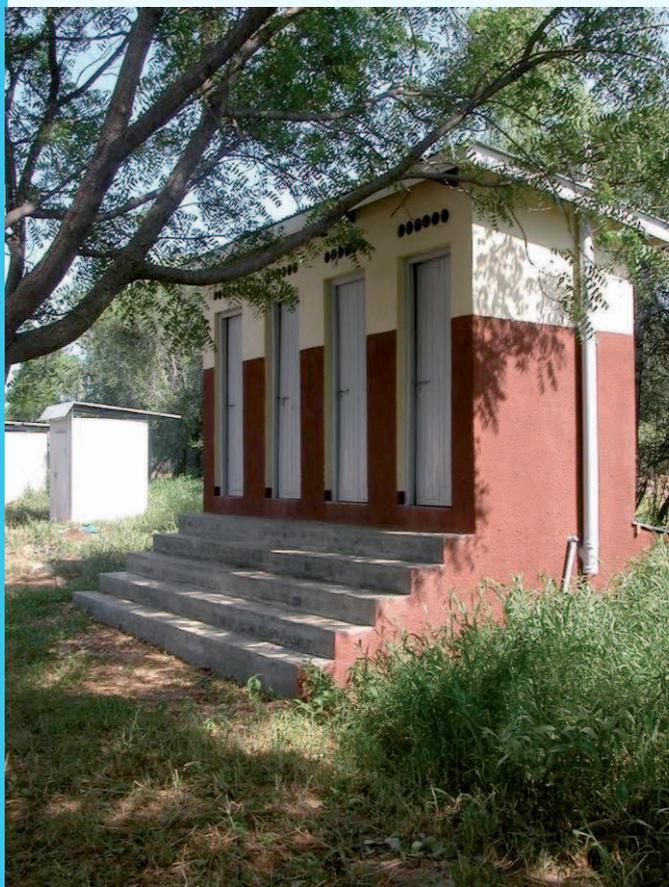
Figure 8. Composting toilets (rebuilt from pit latrines) at Kanawat Health Centre.

A: The requirement was to use the existing pit latrines. They have been constructed above ground due to the rocky underground that did not allow the digging of pits. The volume of the storage chambers for the composting toilets was therefore determined by the existing structure.

A: The composting toilets where constructed without a urine separation to avoid misuse of the toilets due to the high fluctuation in the hospital. Further it was assumed that the hospital staff will not be able/willing to train every day all new patients and family members regarding the correct use of composting toilets.

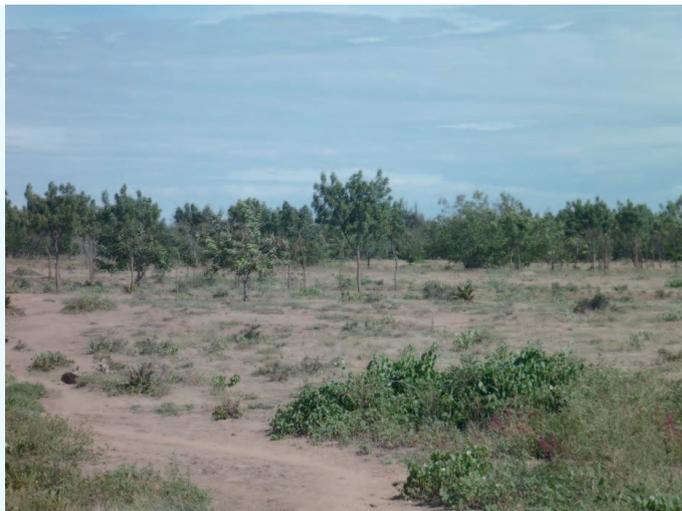
Figure 9. Reforestation area.

A: According to measurements the constructed wetland performs well in terms of treatment. The system is also operated well as the treated water is used for irrigation of a forest. Reforestation is an important topic in this area.

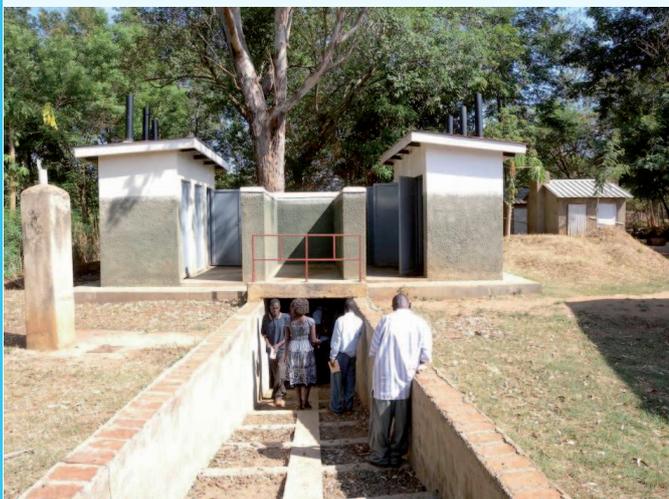
Figure 10. Toilet facilities at St. Joseph's Hospital.

A: The composting toilets have been constructed on ground level to allow for easy access for elderly and ill persons without stairs. However, this implicates additional efforts for operation, e.g. emptying the chambers.

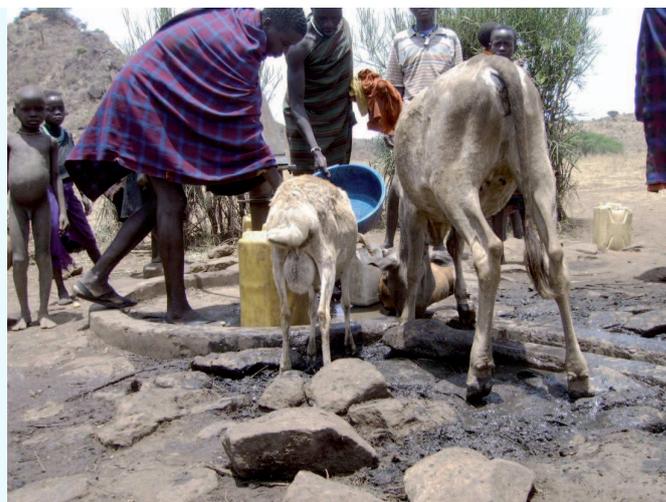
Figure 11. Existing water source lacking management.

A: Management of existing boreholes has been improved a lot.
