# Comparing the treatment efficiency of different wastewater treatment technologies in Uganda

Authors: Muellegger Elke, Markus Lechner

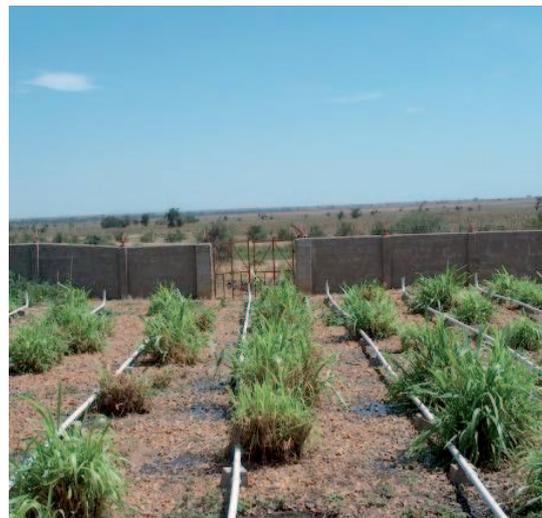
**Picture 1: Vertical flow CW system in Matany Hospital.**

St. Kizito Hospital Matany is a rural hospital in the semi-arid region of Karamoja, in eastern Uganda. The sanitation system is in operation since 1999. Wastewater from flush toilets and showers is treated in a vertical flow constructed wetland system (Picture 1), with a capacity of 625 PE. The wetland is separated in three individual beds and planted with elephant grass (*Pennisetum purpureum*). A three-chamber settling tank serves as wastewater pre-treatment and a mechanical distribution unit enables an intermittent distribution to the three beds. The treated wastewater is collected in a storage tank for irrigation. Furthermore dried sludge from septic tanks and pit latrines is used as soil conditioner. Both fractions are only used to fertilise trees. The plant was designed for an organic load of 47 g COD/m<sup>2</sup>/d. For this

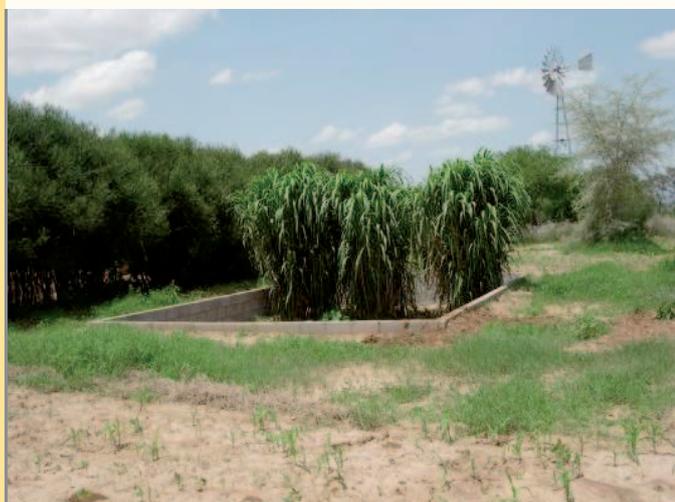
**Picture 2: Horizontal flow CW system in Kanawat Health Centre.**

Kanawat Health Centre is located in the north-east of Karamoja. The sanitation system was completely replaced in 2003 and 2004. Wastewater from flush toilets is treated in a horizontal flow constructed wetland system (Picture 2), with a capacity of 30 PE. The filter bed is planted with elephant grass. A three-chamber settling tank is pre-treating the wastewater and a sludge drying bed was constructed for stabilised sludge from the settling tank. An underground collection tank is storing the treated wastewater for irrigation of trees. Staff of the health centre is using urine diverting dry toilets, one block with four units. The treatment plant was designed for an organic load of 53 g COD/m<sup>2</sup>/d.

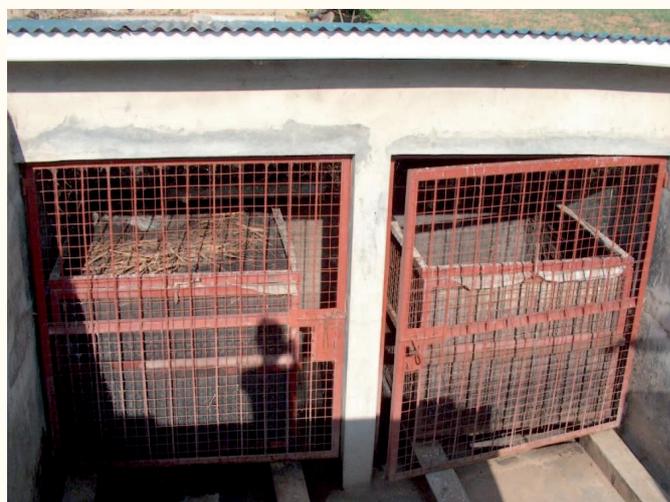
**Picture 3: Filter baskets as wastewater pre-treatment in Maracha Hospital.**

constructed wetland, which has a capacity of 250 PE. The bed is planted with elephant grass. Two intermittently fed filter baskets are serving as pre-treatment (Picture 3) and a distribution chamber enables an even distribution to the filter beds. Treated wastewater is discharged to the environment. Additionally two blocks of urine diverting dry toilets, each with eight toilets, are in use. Sludge from the filter baskets and dried faeces from the urine diverting dry toilets are composted and used in the hospital's own vegetable garden and sold respectively. The treatment plant was designed for an organic load of 65 g COD/m<sup>2</sup>/d.

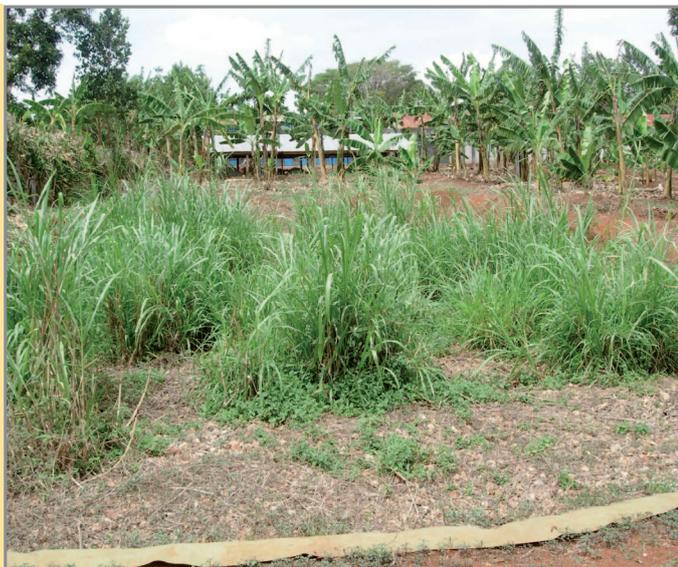
**Picture 4: Horizontal flow CW system in Kalungu.**

Kalungu Girls Secondary School is a rural boarding school in the tropical South of Uganda. The sanitation system is in operation since 2003. Wastewater is treated in a horizontal flow constructed wetland (for 165 PE), planted with elephant grass (Picture 4). The system is treating mainly greywater and a small share of blackwater from three flush toilets. The collected wastewater is pre-treated in a three-chamber settling tank. After treatment it is infiltrated into the ground and not reused as the amount of water is very little. For excreta management 45 single vault urine diverting dry toilets for pupils and one for teachers are in use. The collected faecal material is further treated in a composting area. Dried faeces and urine are used as fertiliser in the school garden. The treatment plant was designed for an organic load of 160 g COD/m<sup>2</sup>/d.

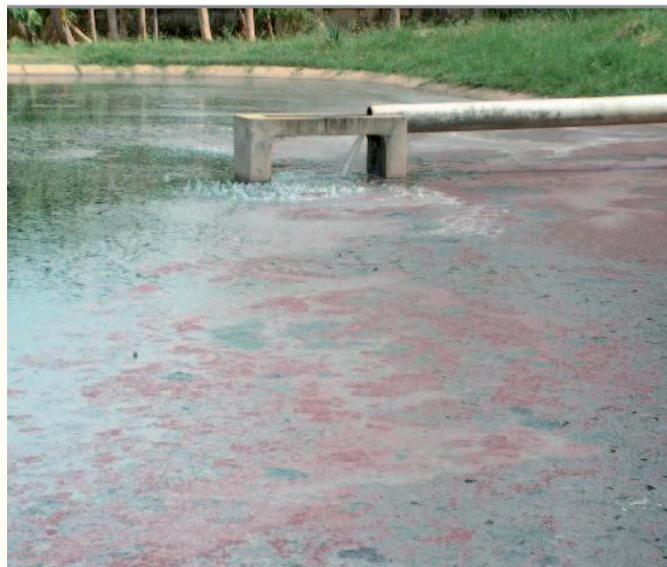
**Picture 5: Inlet into the first pond in Lacor Hospital.**

Lacor Hospital is a rural hospital in Northern Uganda. A conventional pond system (Picture 5) for treatment of mixed wastewater is in operation since the 1990s. In 2005 a "natural filter" has been constructed, because of insufficient treatment of wastewater. The "natural filter" is a fenced area planted with elephant grass, aiming to increase the treatment efficiency of the system. Treated wastewater is not used.
