Yellow Phragmites: Significance, Cause, and Remedies

Preliminary observations of chlorosis of the leaves of Phragmites australis growing in some aerobic treatment wetlands, including discussion of significance, cause and remedies.

Author: Chris Weedon

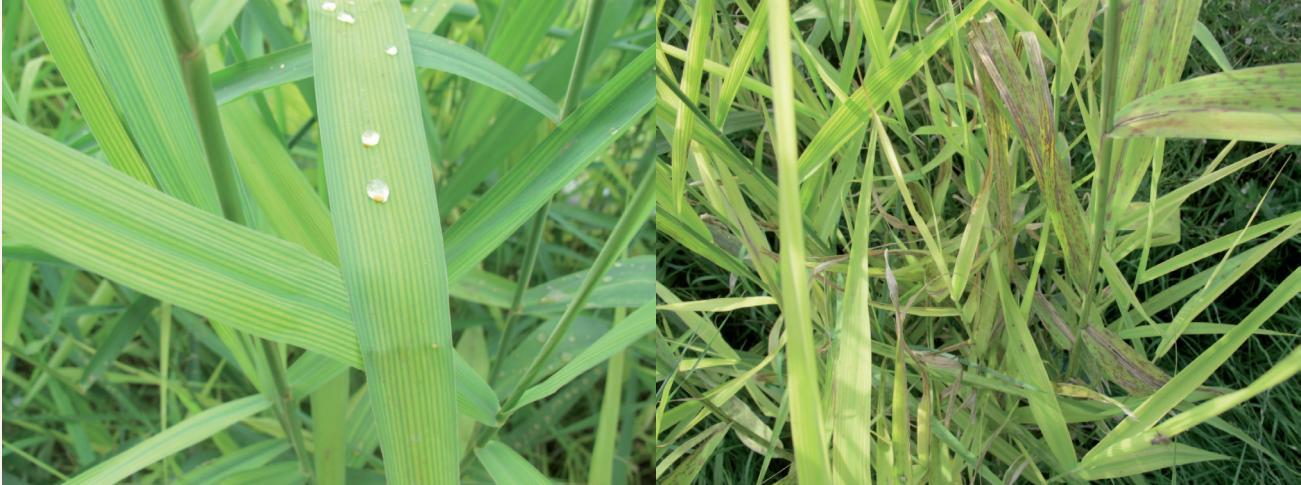
Figure 1a: Chlorotic Phragmites australis leaves showing yellow & green striation (Bodiam Castle, 16Jul13); note droplets of FeSO4 on leaf surface, following spraying

Figure 1b: Chlorotic Phragmites australis leaves showing increased susceptibility to rust attack (Bodiam Castle, 16Jul13)

Distinct yellowing, usually in combination with green & yellow longitudinal striation (Figure 1), of the majority of the leaves of the majority of Phragmites australis plants was reported to be typical, in:

This approach was taken at Bodiam Castle, with iron application on 16 July 2013 (i.e. mid-growing season; following the Leipzig meeting). Close inspection of Figure 1a reveals droplets of FeSO4 solution on the leaf surface, suggesting poor Fe uptake into the leaves. However, surface droplet appearance is consistent with leaf iron uptake [CA]. Eight weeks after application, no discernible decrease in chlorosis was evident. However, their was an improvement in plant health, the leaves appearing more turgid than at the time of iron spraying.

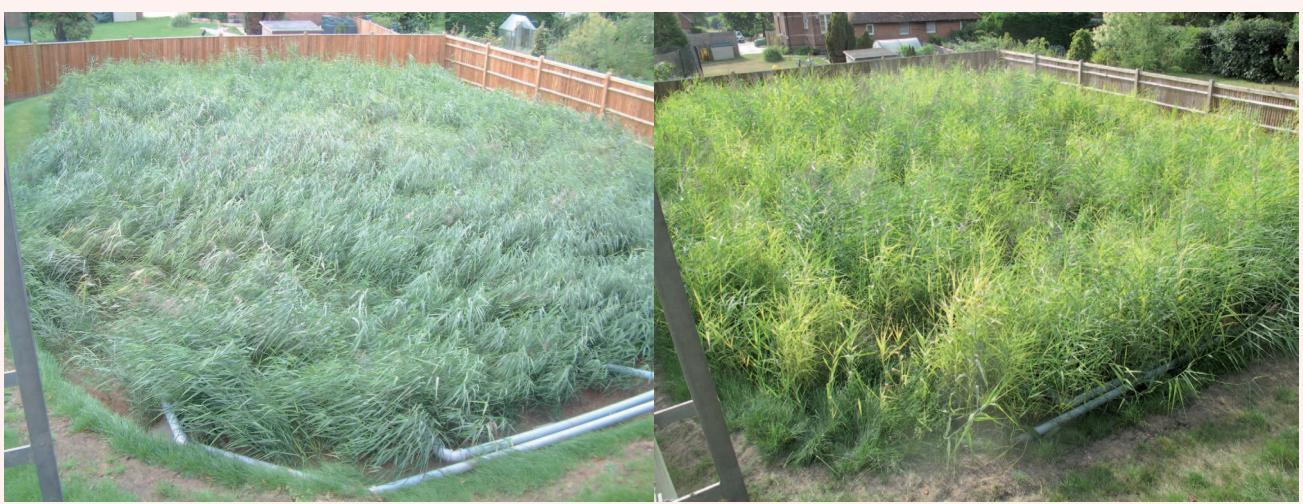
Figure 2a: Bodiam Castle reed bed, during first growing season, with no effluent recirculation, showing dense, green reeds throughout (12Sep11)

Figure 2b: Bodiam Castle reed bed, third season, with effluent recirculation, showing less dense, yellow reeds throughout (even following ferrous sulphate foliar spray on 16Jul13) (22Aug13)

Table 1 shows the influent concentrations, and operational parameters from 2 CW systems in UK, i.e. Bodiam Castle (Figure 2) and Pont Abraham (Figure 3), as well as the leaf colour of reed in different growing seasons.

The same plants growing in seasons both before and after periods of chlorosis (Bodiam Castle & Pont Abraham compact vertical flow reed beds) but fed with poorly oxygenated sewage effluent, with low redox potential, and relatively high ammonia yielded "normal" chlorophyll levels and were green throughout. Figure 5b: Langenreichenbach horizontal flow forced aeration reed bed, receiving settled effluent: progressively shorter, yellower reeds further from inlet (13Jun13)

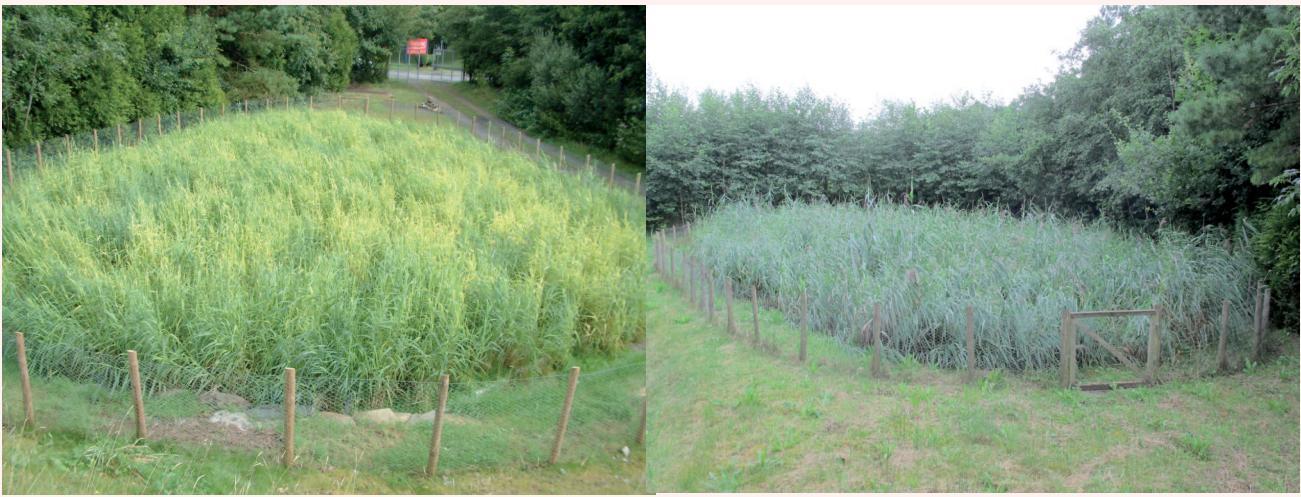
Figure 3a: Pont Abraham reed bed, during first growing season, receiving well aerated RBC effluent (diluted with groundwater infiltration), showing yellow reeds throughout (13Aug08)

Figure 3b: Pont Abraham reed bed, fifth season, receiving settled sewage (undiluted), showing dense, green reeds throughout (21Aug12)

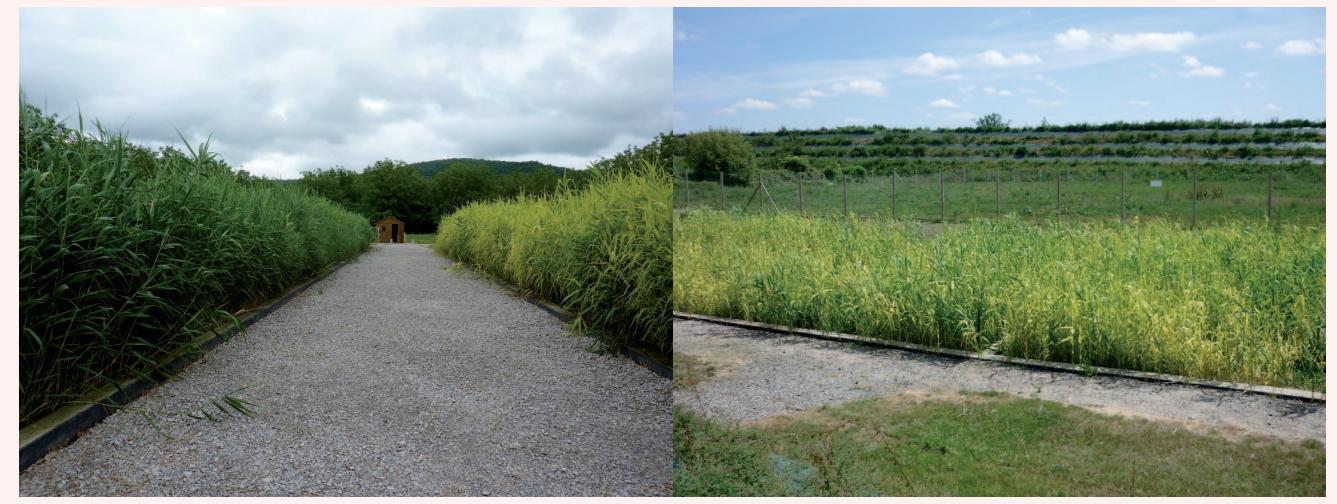
Figure 4a: Floirac first and second stage French system reed bed (left & right, respectively), showing yellowing of leaves in second stage, compared to vigorous green leaves in first stage (courtesy Joëlle Paing) Figure 4b: Hauterive second stage French system reed bed, May 2011, receiving vertical down-flow reed bed effluent treating raw sewage, showing some yellowing throughout bed (courtesy Joëlle Paing)

Of the many two stage vertical down-flow French systems in existence (first stage receives raw sewage; second stage receives effluent from first stage), a small proportion exhibit strong chlorosis of the second stage reeds (Figure 4) [JP], the most extreme resulting in almost complete disappearance of reed plants, replaced by terrestrial "weed" species (Figure 4d).

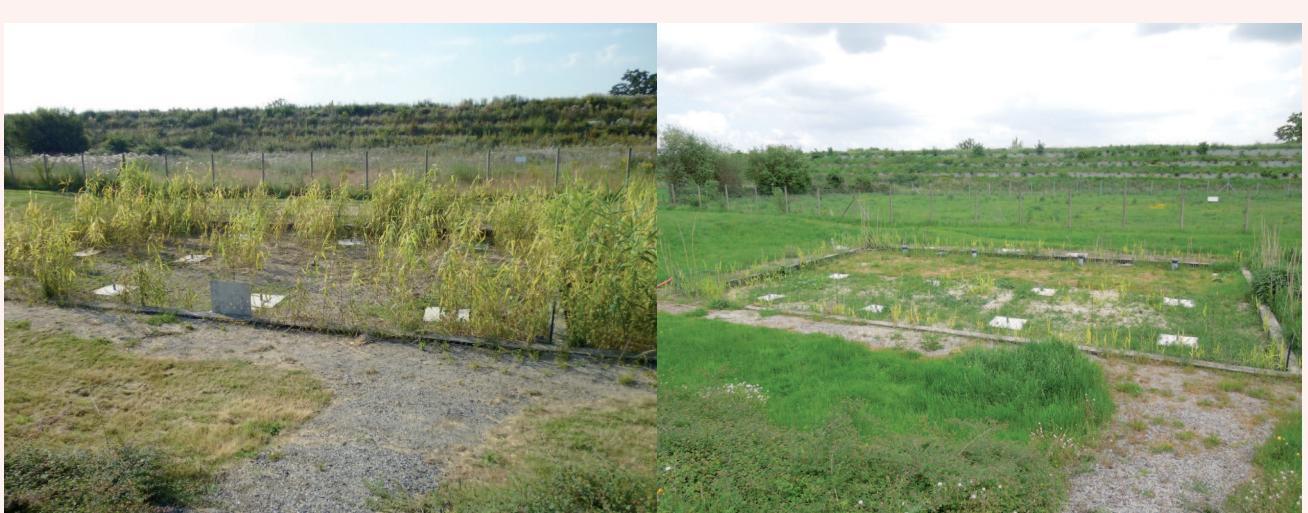
Figure 4c: Hauterive second stage French system reed bed, July 2012, showing poor health and disappearance of reeds creating significant reed-free areas (courtesy Joëlle Paing) Figure 4d: Hauterive second stage French system reed bed, May 2013, almost complete disappearance of reeds within three years of first yellowing, with replacement by "weeds" (courtesy Joëlle Paing)

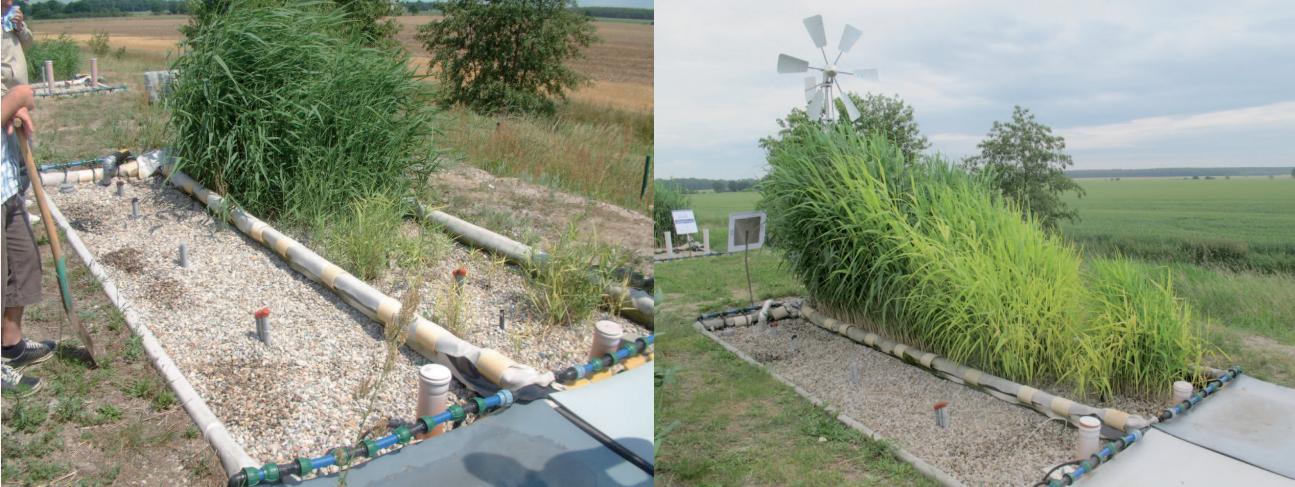
Figure 5a: Langenreichenbach horizontal flow forced aeration reed bed, receiving settled effluent: tall, green, dense reeds near inlet; short, yellow reeds further from inlet (1Jul11)

Langenreichenbach horizontal subsurface flow forced aeration reed bed (Figure 5), from early development, exhibited a striking plant morphology pattern, correlating with distance from the point of settled effluent entry to the bed: tall, green plants at the proximal end with progressively yellower and shorter plants along the bed.

The observations of Langenreichenbach (Figure 5) can, therefore, be explained $(BOD_5, NH_4-N, NO_3-N \& DO data from Tom Headley & Jaime Nivala, 2011, pers comm):$

- 1. Settled effluent flows from one end of the bed to the other, at a depth of approx 1000mm
- 2. Aeration is provided evenly throughout the length of the bed (via subsurface compressed air supply)

- Growing medium (ie sewage effluent) at the inflow end is relatively high in BOD₅ and NH₄-N, the microbial degradation of which sustains a relatively low DO and redox potential, despite the continuous oxygen supply, combined with H⁺ release from nitrification – consistent with conserving Fe²⁺, allowing sufficient iron uptake to ensure normal chlorophyll synthesis, and the observed green plants

- 4. As effluent proceeds along the bed, it becomes progressively lower in BOD₅ and NH₄-N, allowing a higher DO to pertain
- In addition, NO³⁻, produced from nitrification, is taken up by the *Phragmites* as a N source, with concomitant uptake of H⁺

- 6. Therefore, passage along the bed results in the effluent iron being oxidised from Fe²⁺ to Fe³⁺, which additionally encounters conditions of decreasing [H⁺], so falling out of solution and depleting the Phragmites of an essential nutrient; hence chlorophyll synthesis becomes progressively less, correlating with decreased root iron uptake, resulting in the observed decreasing plant height and increased chlorosis with distance from sewage inlet.

Explanation of the observed growth pattern, during a site visit in 2011 (Figure 5a), favoured progressive N source depletion, with N removal by denitrification suspected in the proximal (green plant) zone. This explanation has now been superseded. The symptoms of N-limitation in *Phragmites* are green but shorter plants, rather than chlorosis [BS].
